BAND-IT

PRODUCT TEST REPORT

TEST REQUESTED BY	Aker
ATTENDEES	Steve Franklin / John Bowmer – Band-It Ltd Hermod Iverson – Brady Texit Norway Dick Granli / Arnt Egeland - Aker
COPIES CIRCULATED TO	John Bowmer / Matt Stillings. Pending official SINTEF report to be distributed to Band-It / Texit / Aker.
TEST DESCRIPTION	Performance of Coated Band (double wrap & single wrap) during electrical short circuit of trefoil cable runs.

ITEMS TESTED
AE435 PPA571 Coated 316s/s Band 5/8" wide used with LE155 clip (double wrap) and AE455 clip (single wrap).

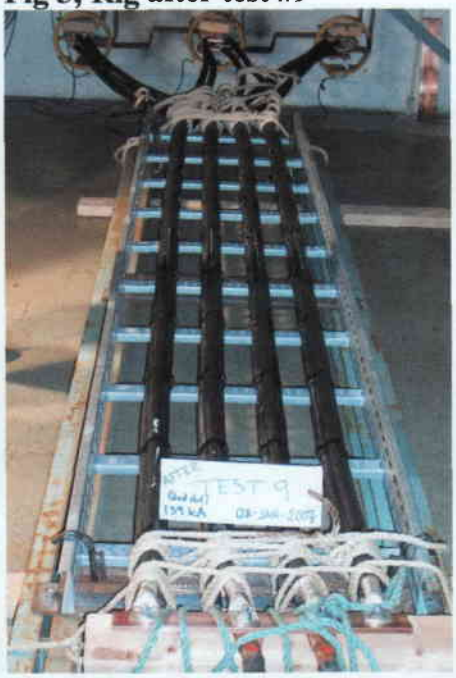
Fig 5; Rig after test #9

After tests 7 (132kA), 8 (139kA) and 9 (139kA) there appeared to be no change other than slight movement now in all 4 cable runs due to ladder distortion.
After test 9 the bands were removed and the cable was inspected for damage. No damage to the cable was evident.
The test rig was then re-fitted with double wrap bands on a **single** trefoil run of cable using different slots in the cable ladder (so that any deformation in the slots could be seen). It was expected that this would exert much higher loading on the bands since the forces tend to be evenly spread between parallel cable runs.
After test 10 (65kA) the bands remained intact, although slight slippage in some clips was evident (1-2mm), along with distortion of the ladder slots.
After test 11 (64kA) further slippage in the clips and further slot distortion was seen, but all bands remained intact. The bands were then removed and replaced with single wrap for test 12.

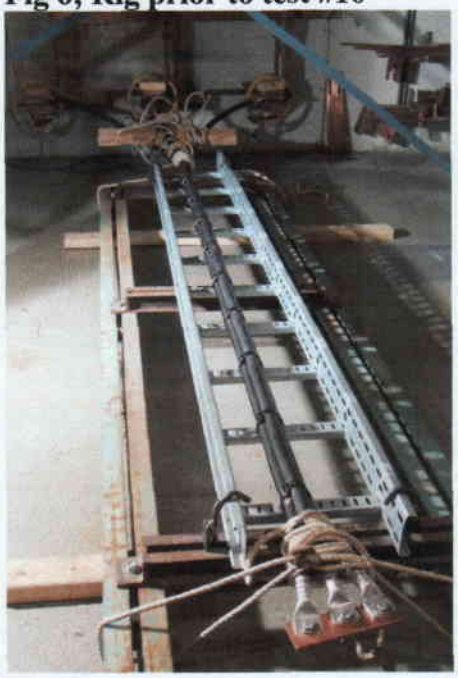
Fig 6; Rig prior to test #10

Single run of trefoil.

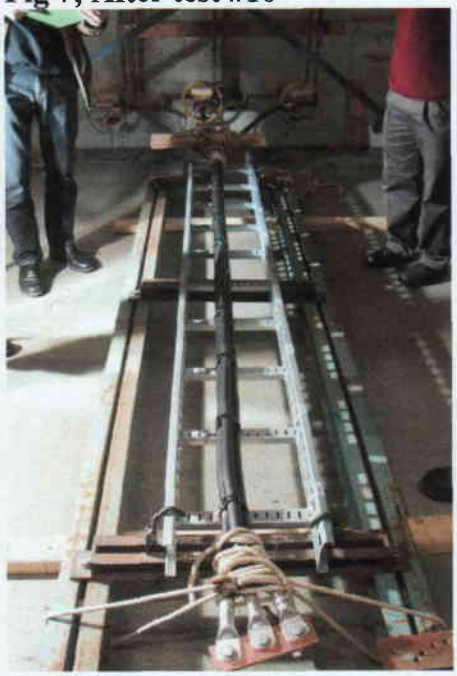
Fig 7; After test #10

(Double wrapped band)

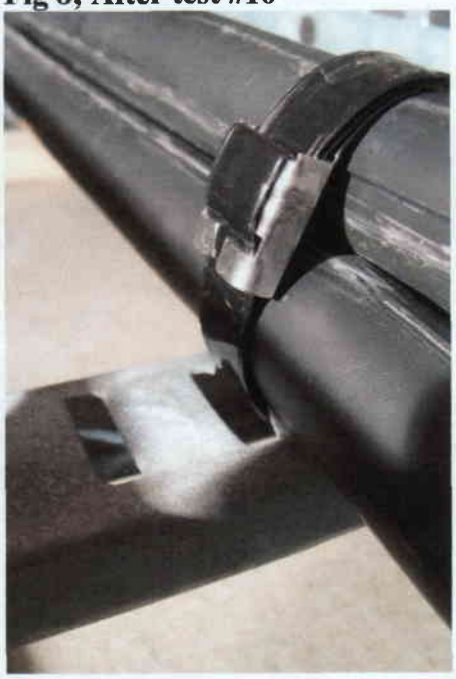
Fig 8; After test #10

Close-up of band

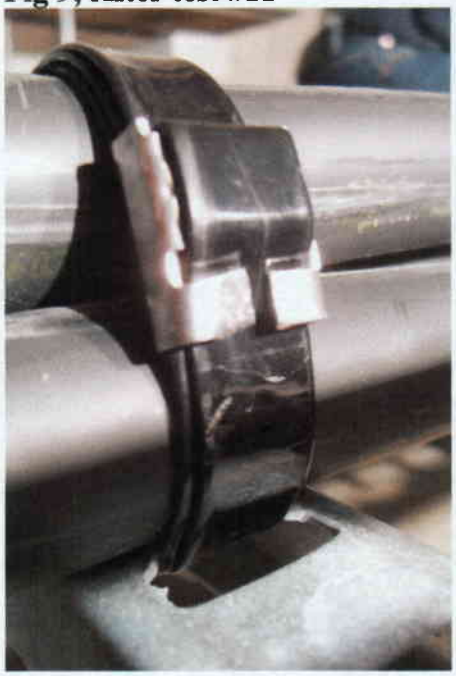
Fig 9; After test #11

Visible slippage of band in clip.

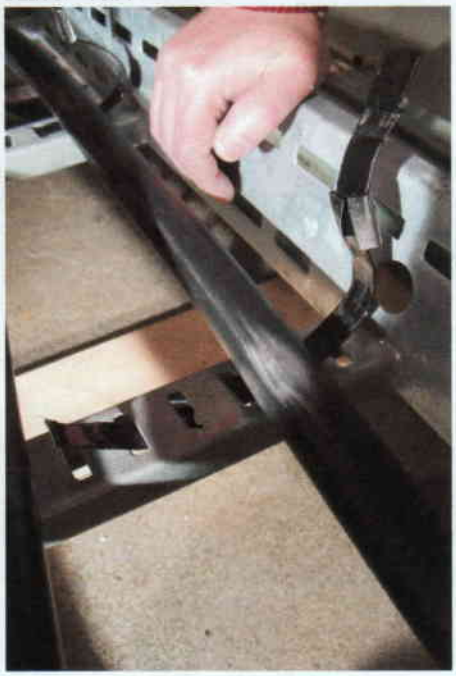
During test 12 (62kA) all of the (single wrapped) bands failed by way of the band pulling through the clips. The cable ladder was also severely distorted.

Fig 10; After test #12

All bands failed on single wrap.

Close up of failed band.
